# Codornices Creek Restoration Project

## 2014 Monitoring Report

City of Albany / City of Berkeley

Prepared By:  
**Restoration Design Group**  
2612 Suite B, Eighth Street  
Berkeley, California 94710

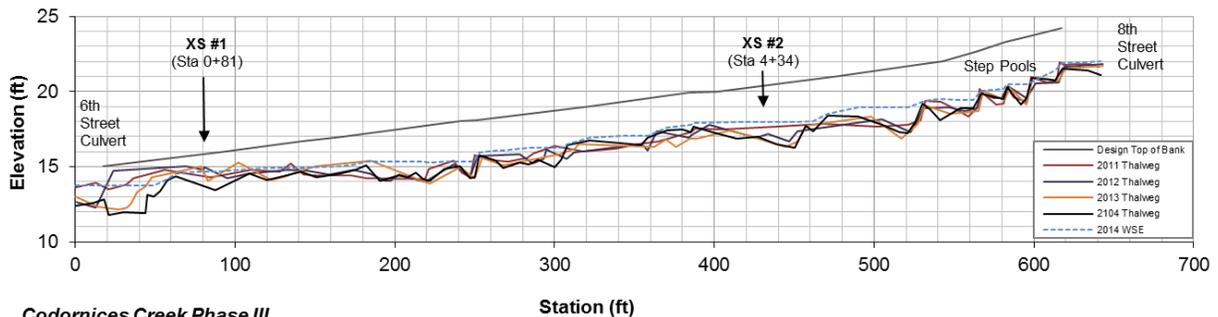
**Codornices Creek Phase III**  
Channel Profile

The mild 2013/2014 winter resulted in little change within Phase 3. Much of the bed has maintained a consistent elevation. Some pools have continued to scour and a few riffles aggraded by accumulating fine sediment among the emergent vegetation that persisted through most of the winter. The channel adjustments that occurred during the first winter upstream of the 6<sup>th</sup> street culvert have slowed and the channel has recreated a single threaded channel in this area. The upstream step pools have remained stable.

Riffle and pool morphology continue to develop within the channel with the exception of areas scoured to hardpan. The hardpan is hampering sediment deposition in these areas and limiting development of depositional feature such as point bars. Emergent vegetation was thick during the summer and led to minor sedimentation within the active channel except in the location of the hardpan, which remained exposed throughout the summer.

**Expose Hardpan** –The exposed hardpan upstream continues to persist. This hardpan substrate excludes any opportunity for hyporheic flow and does not provide ideal habitat for benthos. This condition is not unique to the restoration areas. A similar condition exists upstream of the project site between 8<sup>th</sup> and 9<sup>th</sup> street.

Monitoring of this condition began during the first winter after construction and has not shown any indication of improvement. The channel has incised up to 1-foot below the design grade resulting in increased stream power near bankfull flows. In addition, the floodplain is no longer inundated at the designed frequency.

As noted above, there is a large portion of channel that has hard pan clay substrate and does not provide suitable habitat and likely contributes to the elevated stream temperatures seen within Phase 3. Addressing this condition should be considered if there is interest from the regulatory agencies.

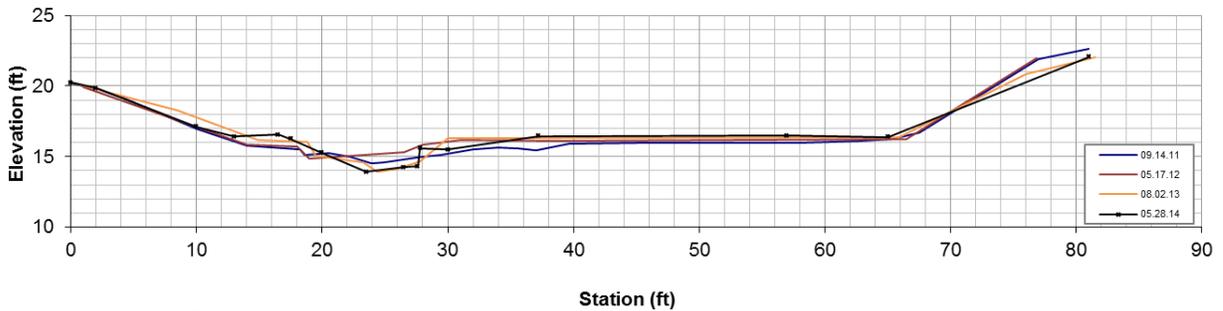
**Codornices Creek Phase III**  
 Cross Section 1  
 Profile Station 0+81

The two riffle cross sections were resurveyed in 2014. Cross section #1 is in the lower portion of the creek and is influenced by the culvert backwater. Cross section #2 is upstream in the location adjacent to the hardpan bed. Cross section 1 shows continued adjustment of the channel above the 6<sup>th</sup> street culvert, with active aggradation of the

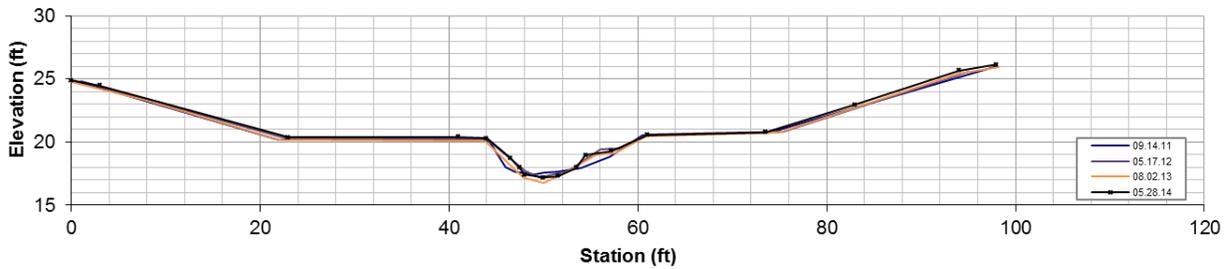
**Codornices Creek Phase III**  
 Cross Section 2  
 Profile Station 4+34

floodplain and narrowing of the channel. Cross section 2 continues to build its inner depositional bench formed in 2012, while maintaining a consistent thalweg elevation.

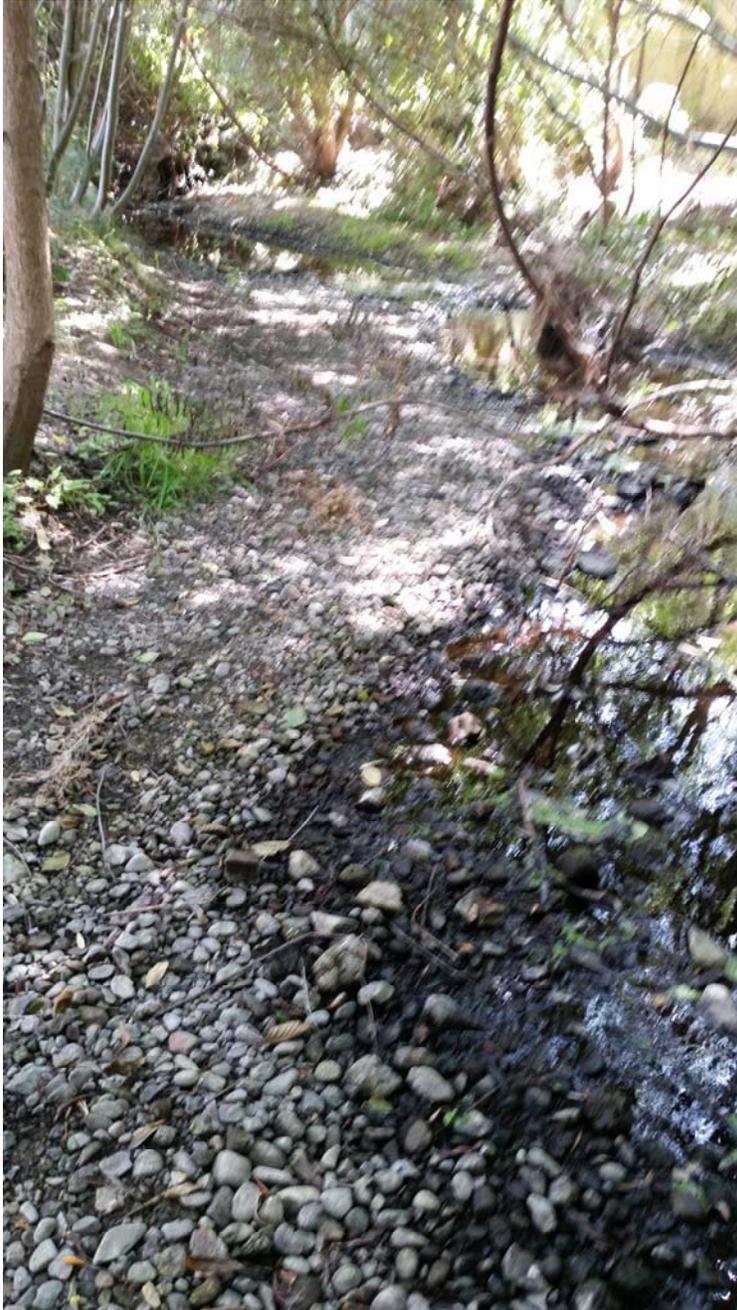
This reach had a total of 105 square feet of potential spawning habitat with relatively clean and non-compacted gravel substrate (Figure 2). That equates to 35 square feet per 100 feet of stream length. Willow root mats were less prevalent in this reach compared to the reach below 5<sup>th</sup> Street. The extensive shallow riffle habitat in this reach hinders migration during summer low flow conditions.

Figure 2. Gravel substrate in Codornices Creek between 5<sup>th</sup> Street and 6<sup>th</sup> Street.

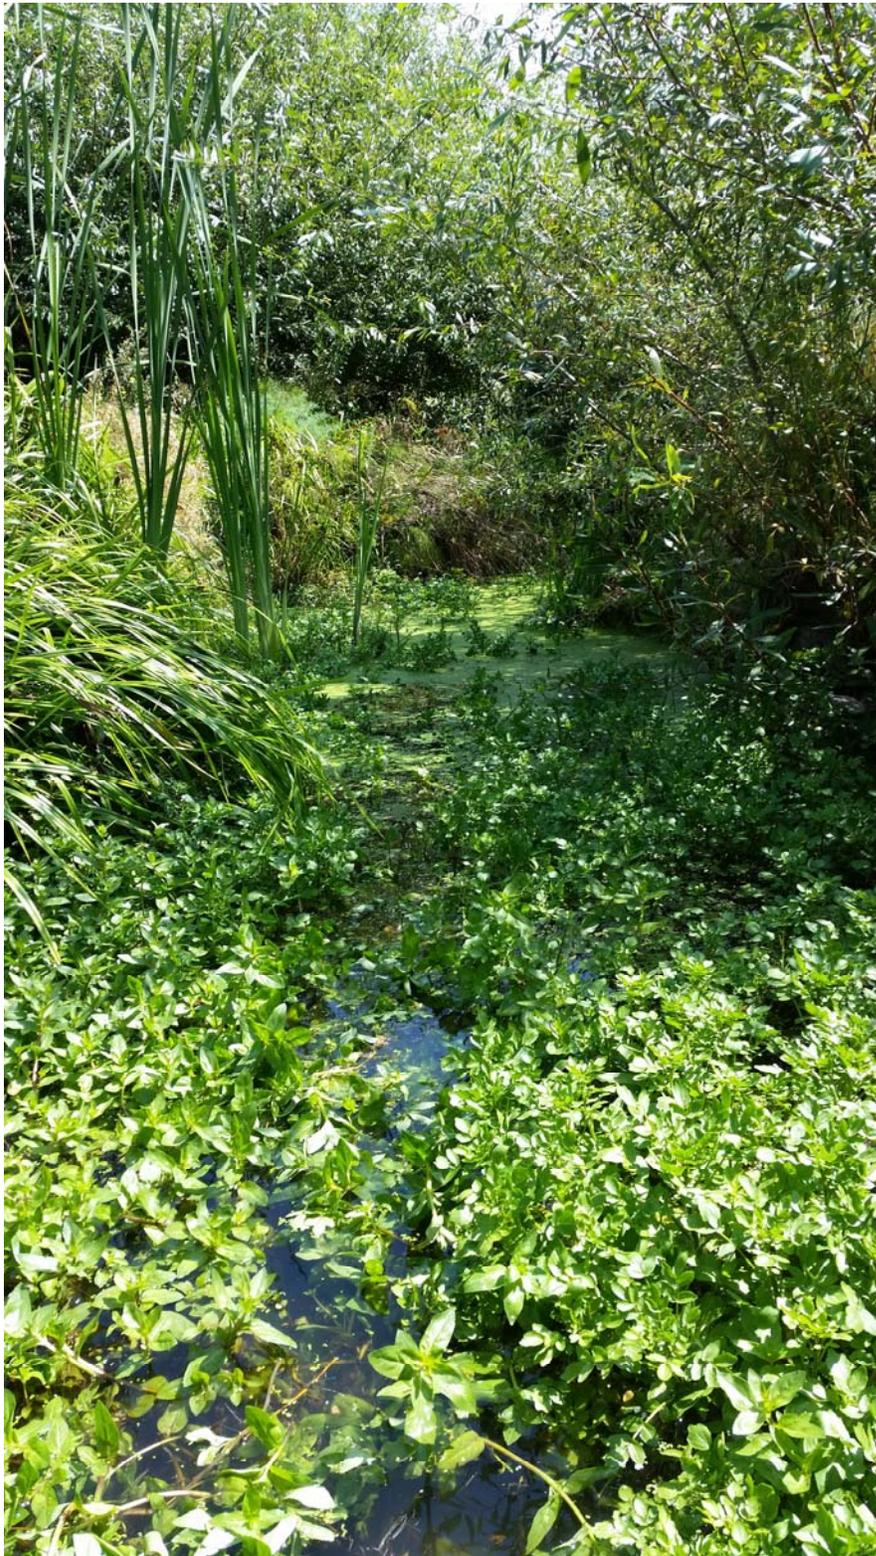
By 2014, there had been some growth of the willows and other riparian vegetation providing additional shading. Although still present in some areas, the extensive growth of emergent aquatic vegetation had been reduced and a defined channel was present through most of the reach (Figure 3). The channel had cut down through the wedge of sediment upstream of the 6<sup>th</sup> Street culvert, noted in the 2012 survey, improving passage through this section.

Figure 3. Codornices Creek upstream of 6<sup>th</sup> Street.
