Codornices Creek Restoration Project

2016 Monitoring Report

City of Albany / City of Berkeley

Prepared By:
Restoration Design Group
2612 Suite B, Eighth Street
Berkeley, California 94710

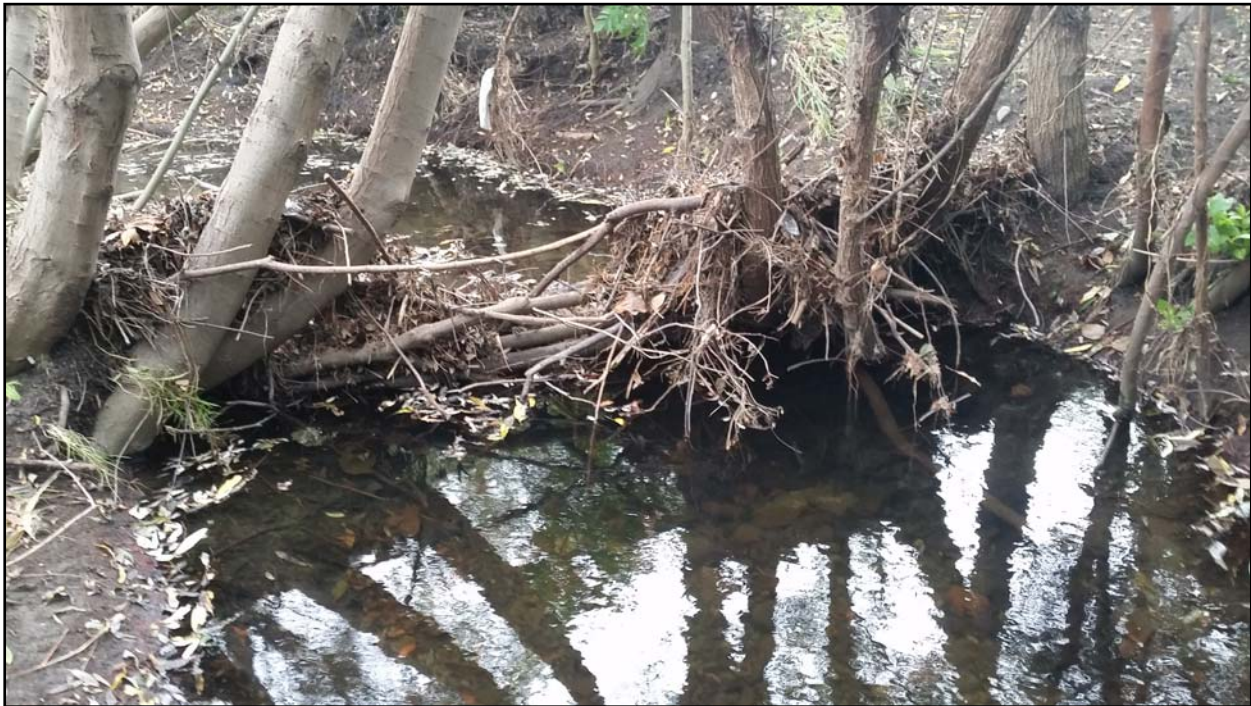
The reach was relatively unchanged from previous surveys in 2009, 2012, and 2014 in terms of channel position and channel cross-section. Small debris jams caused by accumulations of small woody debris were a more common feature than in previous surveys (Figure 2). These small accumulations of wood are not extensive enough to cause flooding or bank erosion and they provide shelter for fish. There is passage under and through the debris for smaller fish and passage for larger fish would be possible at higher flows, when fish are more likely to be moving. Stream wetted width ranged from 2 to 9 feet. The reach is dominated by pool habitat (62% by length), with riffles making up 25% by length. Runs and glides comprise 8% and 5%, respectively. In comparison, previous surveys found pools comprised 70% of the reach length in 2014 compared to 49% of the surveyed length in 2012 and 56% in 2009. Riffles were only 16%

Figure 2. Small debris jam between UPRR crossing and 5th Street.

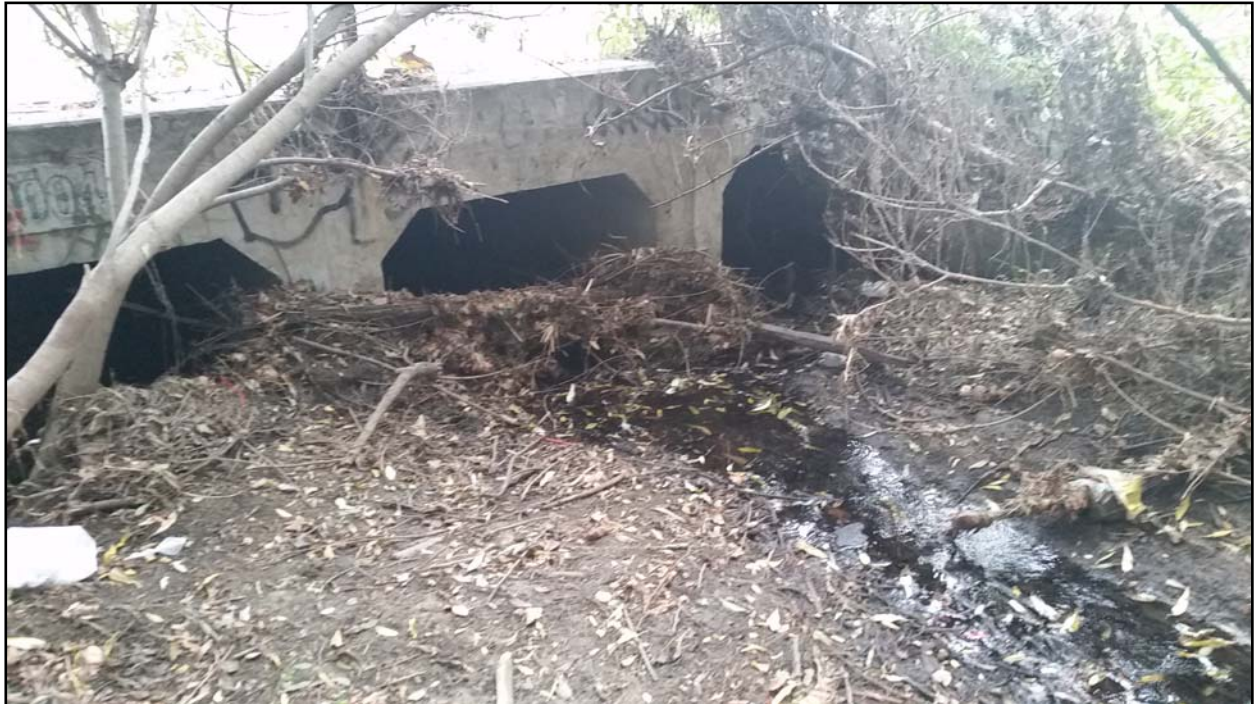
Figure 3. Debris blocking UPRR culvert mouth.

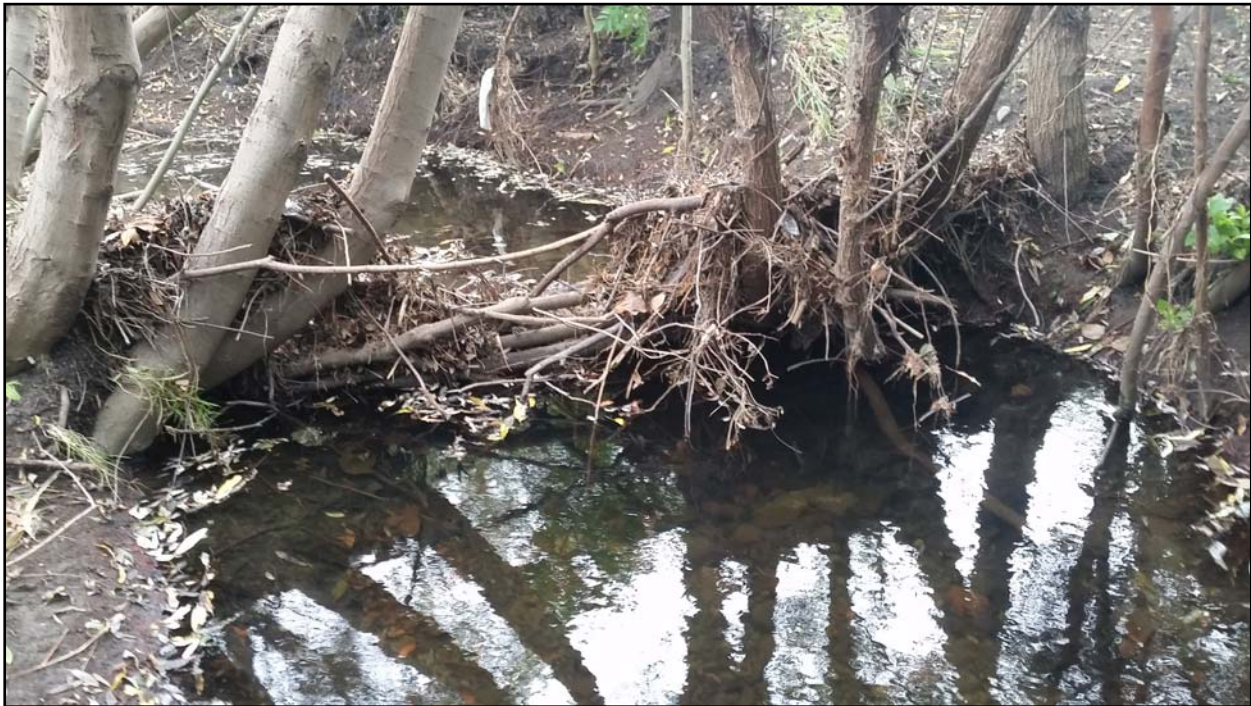
The reach was relatively unchanged from previous surveys in 2009, 2012, and 2014 in terms of channel position and channel cross-section. Small debris jams caused by accumulations of small woody debris were a more common feature than in previous surveys (Figure 2). These small accumulations of wood are not extensive enough to cause flooding or bank erosion and they provide shelter for fish. There is passage under and through the debris for smaller fish and passage for larger fish would be possible at higher flows, when fish are more likely to be moving. Stream wetted width ranged from 2 to 9 feet. The reach is dominated by pool habitat (62% by length), with riffles making up 25% by length. Runs and glides comprise 8% and 5%, respectively. In comparison, previous surveys found pools comprised 70% of the reach length in 2014 compared to 49% of the surveyed length in 2012 and 56% in 2009. Riffles were only 16%

Figure 2. Small debris jam between UPRR crossing and 5th Street.

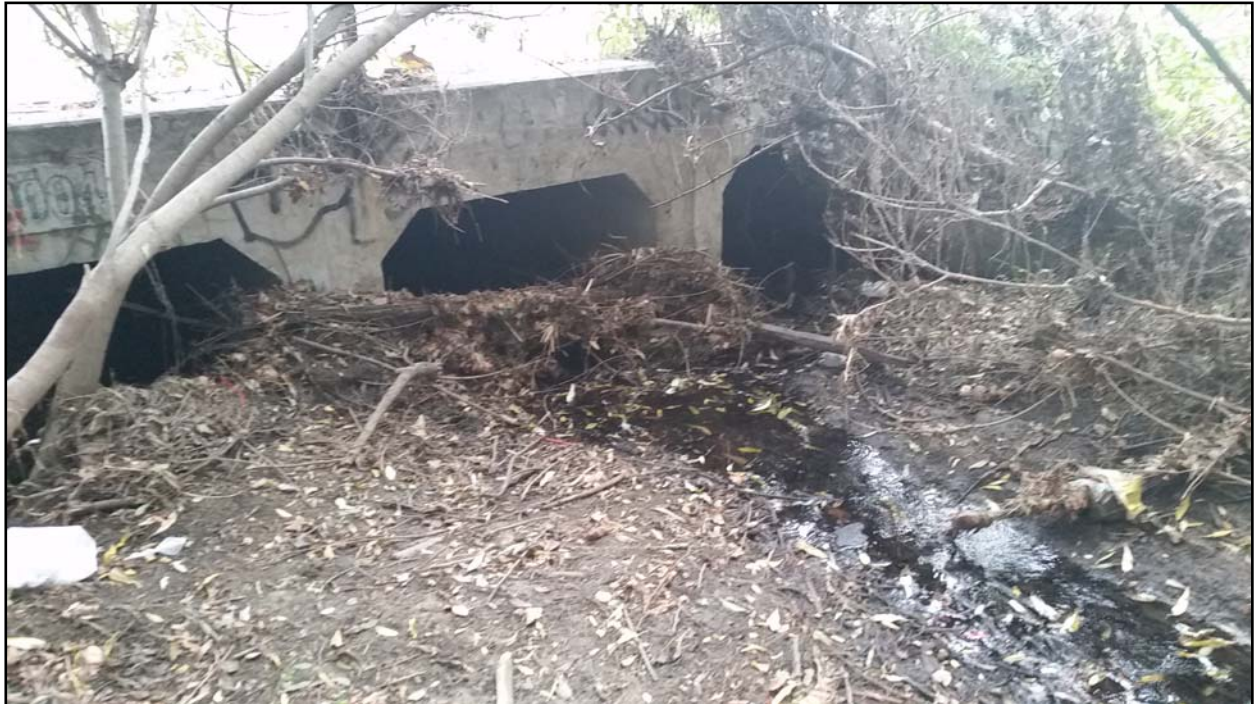
Figure 3. Debris blocking UPRR culvert mouth.
