Codornices Creek Watershed Restoration Action Plan

Prepared for the

Urban Creeks Council

November, 2003

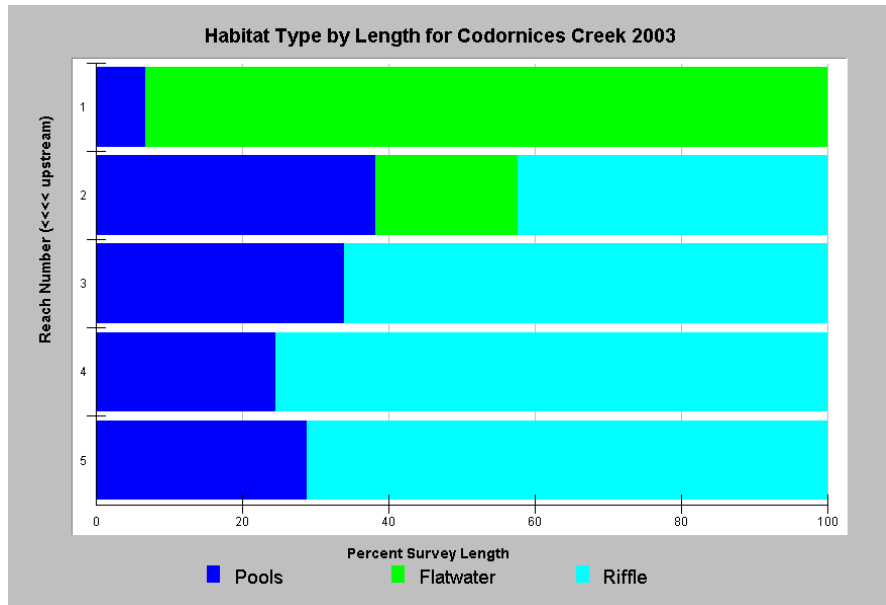
The percentage of stream habitat type by length – pools, flat-water, and riffles – for each of the five study reaches (figure 8, below) indicates that habitat for steelhead in Codornices Creek is presently limited. Pools, for example, make up only 20 percent of the length of the stream.

The California Department of Fish and Game suggests that pool enhancement projects be undertaken where primary pools comprise less than 40 percent of the total length of stream habitat (CDFG, 1998). In first and second order streams, a primary pool is defined as one having a maximum depth of at least two feet, which occupies at least half of the width of the low flow channel, and is as long as the low flow channel is wide.

Figure 8. The percentage of stream habitat type by length for each of the Codornices Creek study reaches

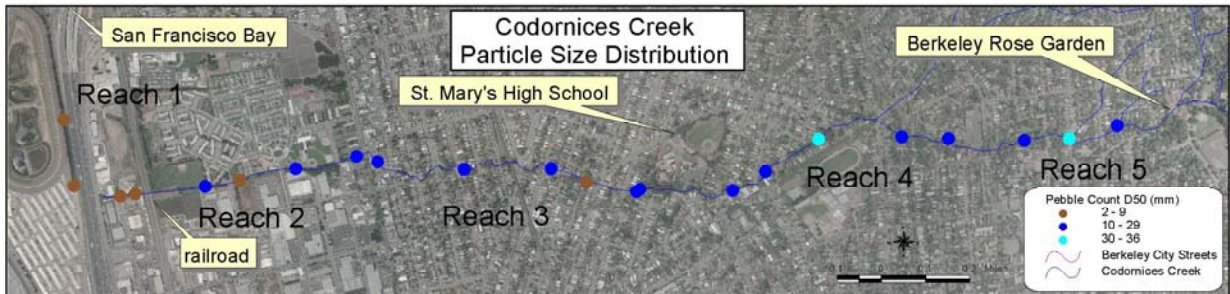
As for the ability of Codornices Creek’s gravels to support steelhead reproduction, Kondolf reported that the streambed particle sizes that are most suitable for supporting successful steelhead spawning, egg incubation, and fry emergence range in size from 10-45 mm (Kondolf, 1993). The median streambed particle size distribution indicates that while a number of Codornices Creek sites tested *below* Albina Avenue are unsuited to these critical steelhead life history stages, the sites tested *above* Albina are all uniformly suitable.

Figure 9. Codornices Creek pebble count sites showing suitable (blue) and unsuitable (brown) gravel areas.

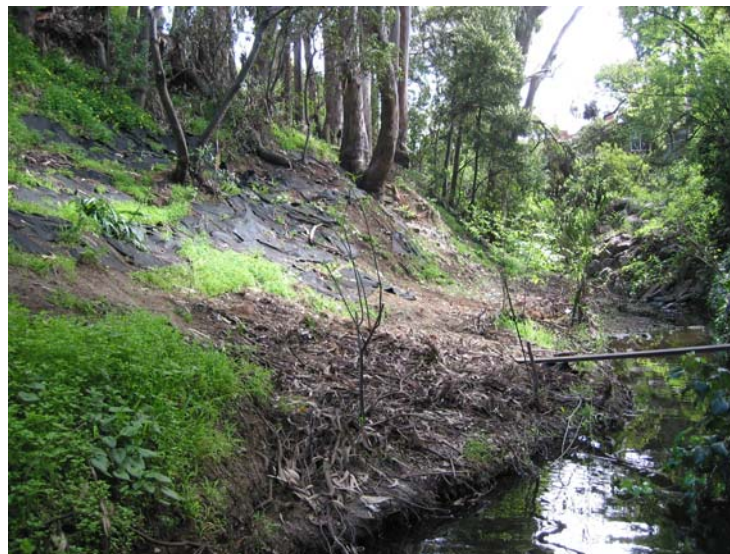
As we noted above, the survey team recorded and geo-referenced streambank erosion sites. The failing hillside shown in figure 10, near St. Mary’s High School, is contributing significant amounts of fine sediment into the stream and it clearly accounts for some of the unsuitability of Codornices Creek’s streambed for steelhead reproduction below this point.

Figure 10. Sediment from the hillside is entering Codornices Creek near Albina Avenue

For each of the problematic sites, including the major erosion site on the right streambank of Codornices Creek near Albina Avenue, FarWest Restoration Engineering has fashioned preliminary restoration recommendations ([Appendix A](#)).

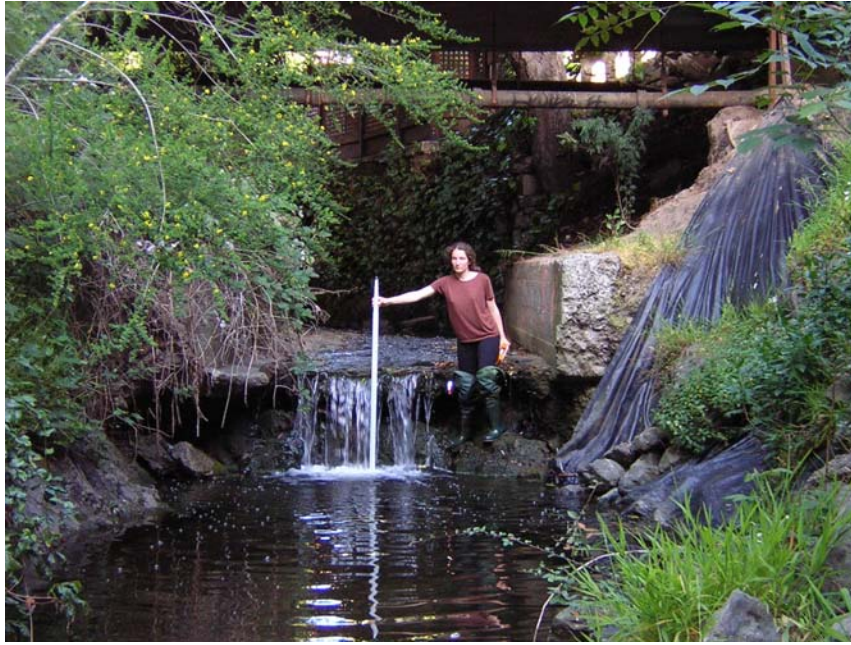
Figure 12 illustrates a typical Codornices Creek steelhead migration barrier. Here, California Department of Fish and Game-trained CCWRAP habitat survey field leader Michelle Wallar measures the distance from the Albina Avenue culvert to the water surface elevation below, and the depth of the scour pour immediately below the culvert.

Adult steelhead could negotiate the jump shown here easily if the depth of the scour pool were equal to more like one-and-a-half times, rather than only one-half, the vertical distance from the stream's surface to the culvert's invert. Another fish passage issue at this site is the spreading of the flow across the relatively wide culvert invert, making the stream too shallow to support effective adult steelhead upstream swimming.

Figure 12. Down-cutting of streambeds below culverts has created most of Codornices Creek's fish barriers

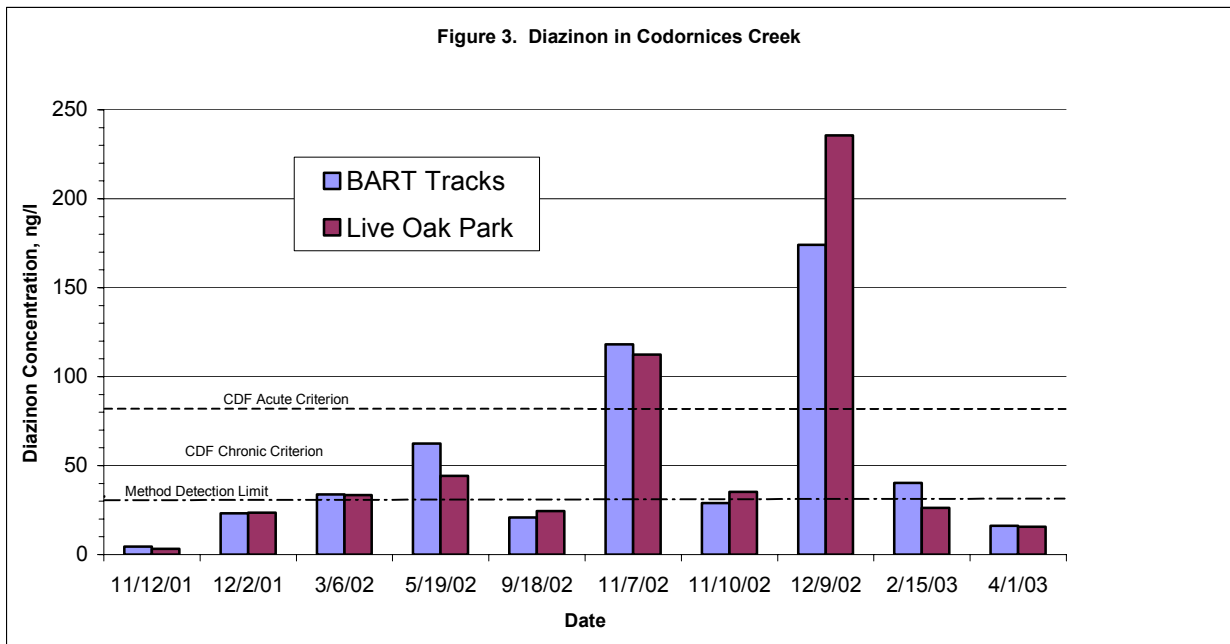
Figure 3 shows the concentrations of diazinon in the samples. On two occasions, samples at both Live Oak Park and the BART crossing exceeded the CDF acute criterion of 80 ng/l. and on one occasion the Live Oak Park sample but not the BART crossing

sample exceeded the acute criterion. Three samples (one from Live Oak Park and two from the BART crossing) exceeded the chronic criterion but not the acute criterion.
