Codornices Creek Phase III

Cross Section 1

Restoration Design Group, Inc
 2332 5th Street, Suite C
 Berkeley, California 94710

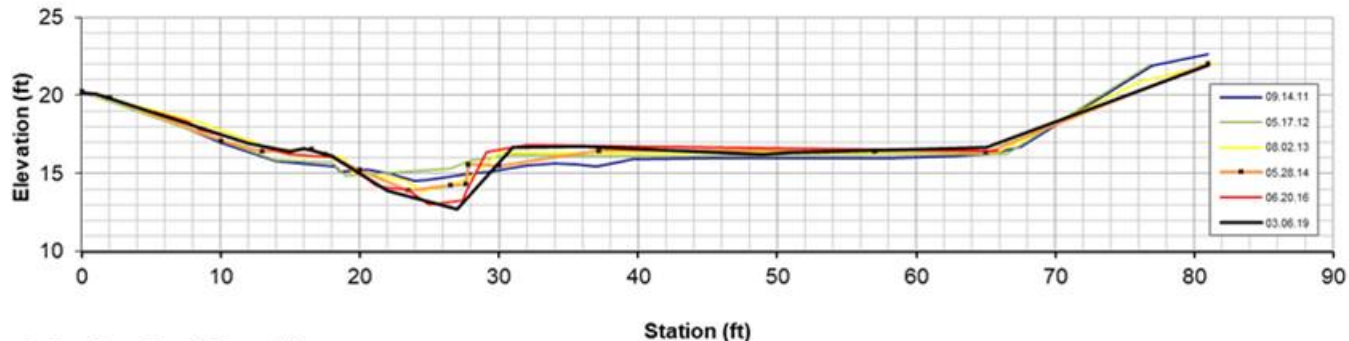
Profile Station 0+81

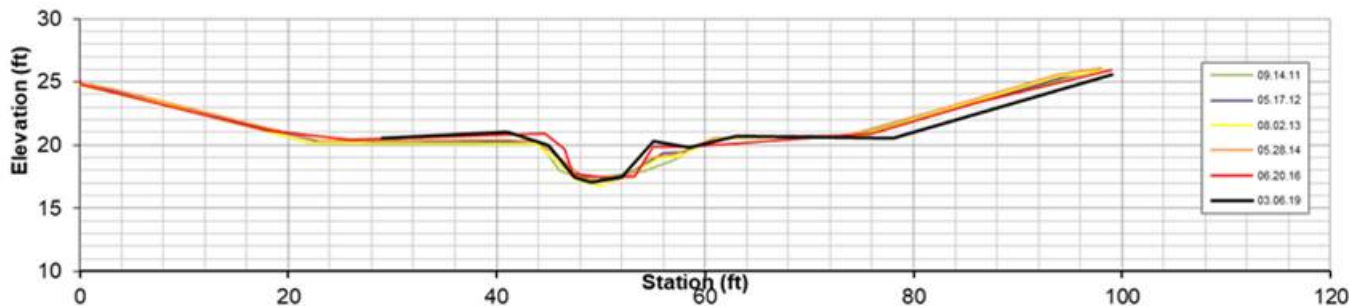
Cross Section 2

Profile Station 4+34

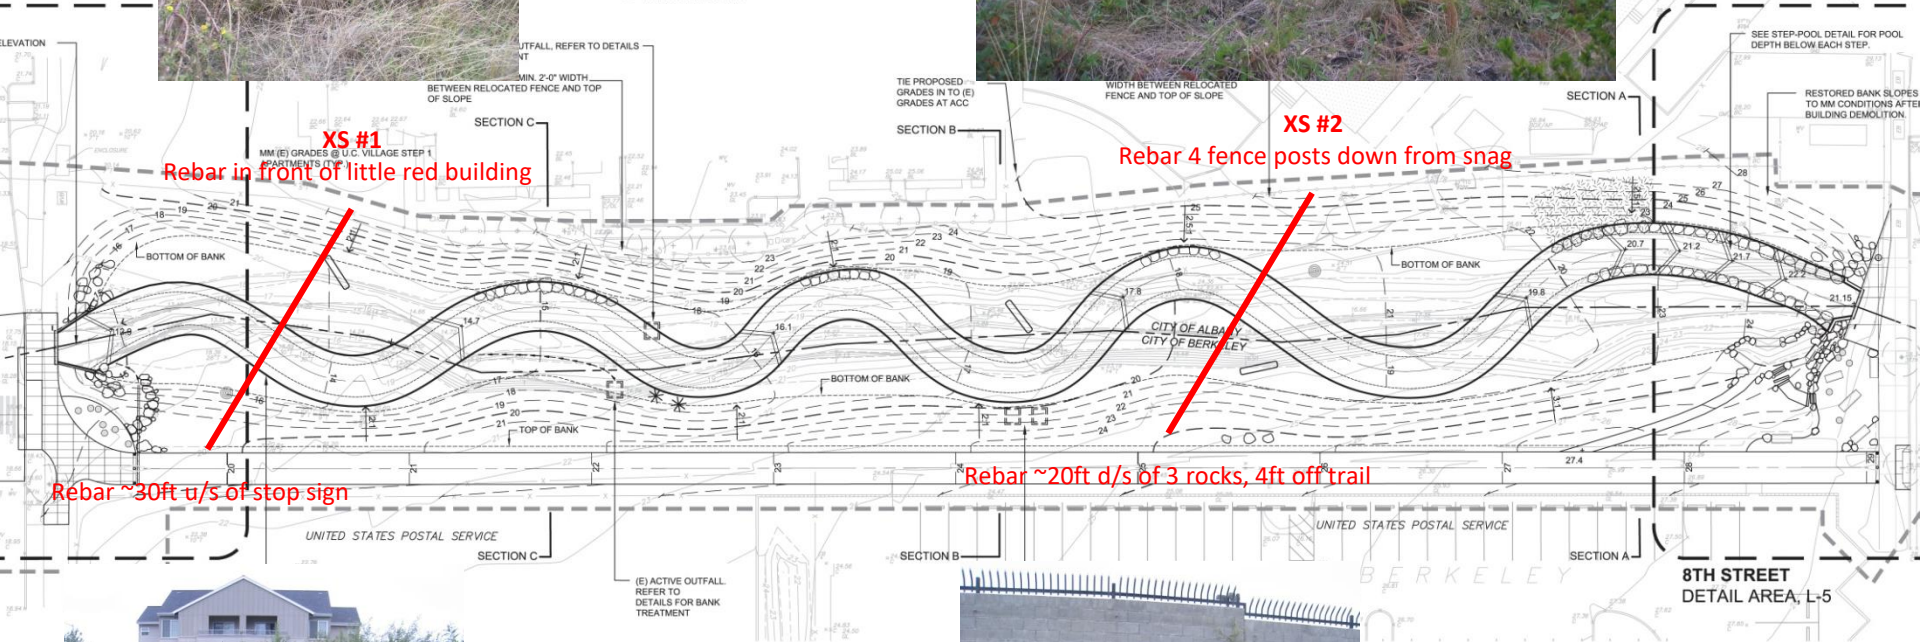
XS #1
Rebar in front of little red building

XS #2
Rebar 4 fence posts down from snag

Rebar ~30ft u/s of stop sign

Rebar ~20ft d/s of 3 rocks, 4ft off trail
