# Codornices Creek Restoration Project

## 2014 Monitoring Report

City of Albany / City of Berkeley

Prepared By:  
**Restoration Design Group**  
2612 Suite B, Eighth Street  
Berkeley, California 94710

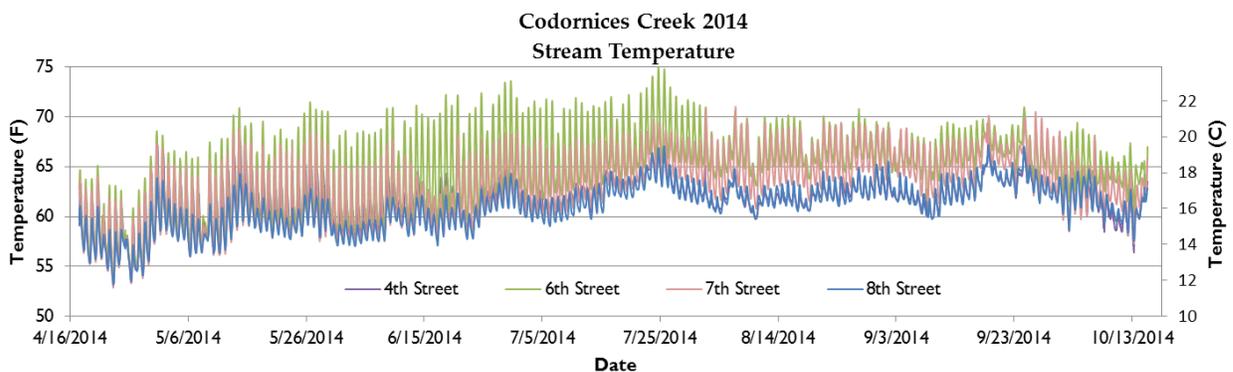
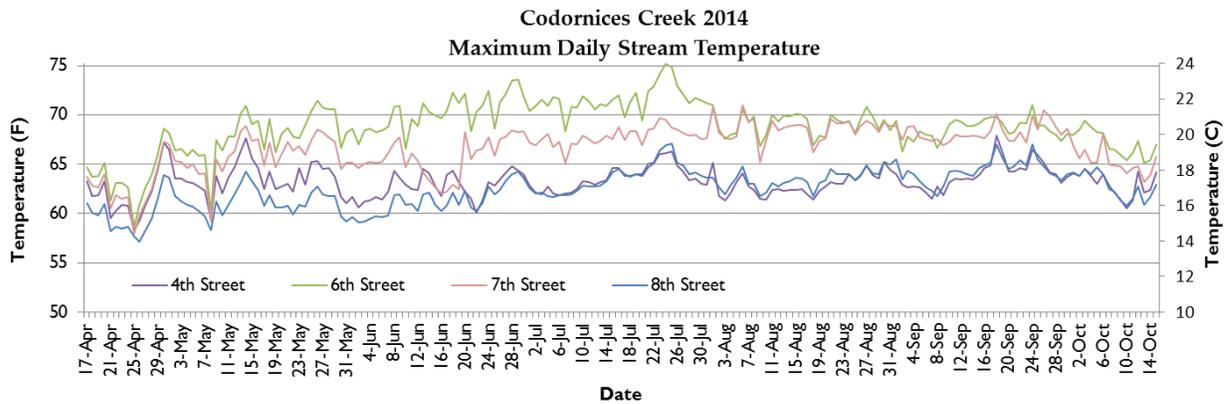
Intermediate temperature readings were completed August 1<sup>st</sup>, 2014 to acquire data from the first half of the season. After reviewing the data for the entire 2014 monitoring period it became clear that the 6<sup>th</sup> street temperature data varied significantly before and after this intermediate temperature reading. Prior to August 1<sup>st</sup>, the daily temperature range varied significantly more than the other loggers, indicating that the logger was partially measuring air temperature at this time. This is further supported by the fact that this particular logger was located in shallow water and the position of the logger was interrupted on August 1st to offload the data. The change in logged temperature is apparent in both Figures below, where readings of the 6<sup>th</sup> and 7<sup>th</sup> street loggers become more closely aligned after August 1<sup>st</sup>.
