Codornices Creek Watershed Restoration Action Plan

Prepared for the

Urban Creeks Council

November, 2003

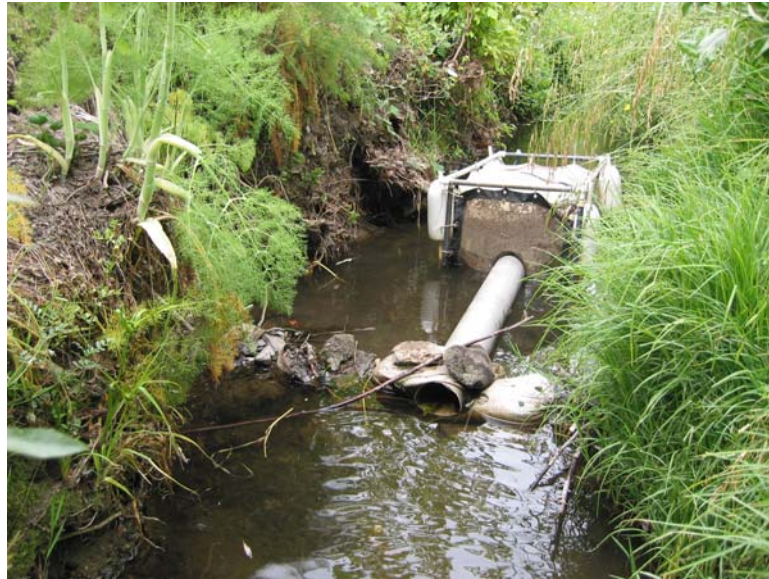
Figure 1. Downstream migrant fish trap operated on Codornices Creek in 2002 and 2003

A storm in early April, 2002, much heavier than expected, caused Codornices Creek to rise so violently in this incised channel that the wings were torn from the trap before the project crew could reach it. With more storms on the way, no attempt was made to restore the trap's wings. The trap operated after that, and for the entire 2003 season, as a simple pipe trap, as shown in Figure 1.

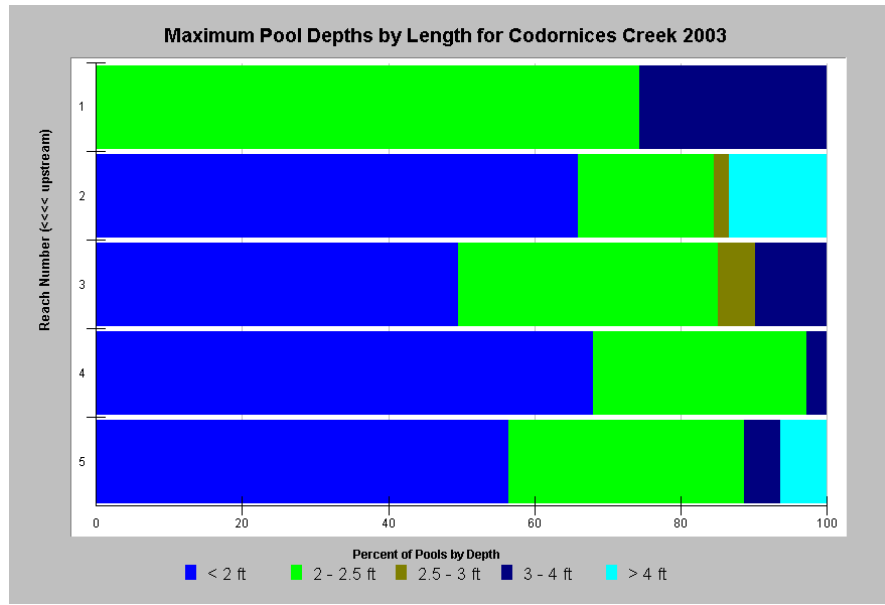
Figure 11. Distribution of pool depths determined from the 2003 Codornices Creek stream survey.

There are 159 pools in reaches 4 and 5, that is, above Albina Avenue. These pools have a combined volume of 14,500 cubic feet. In these two reaches alone there is 17,000 square feet of good quality spawning gravel, enough to support over 90 steelhead redds (spawning “nests”).

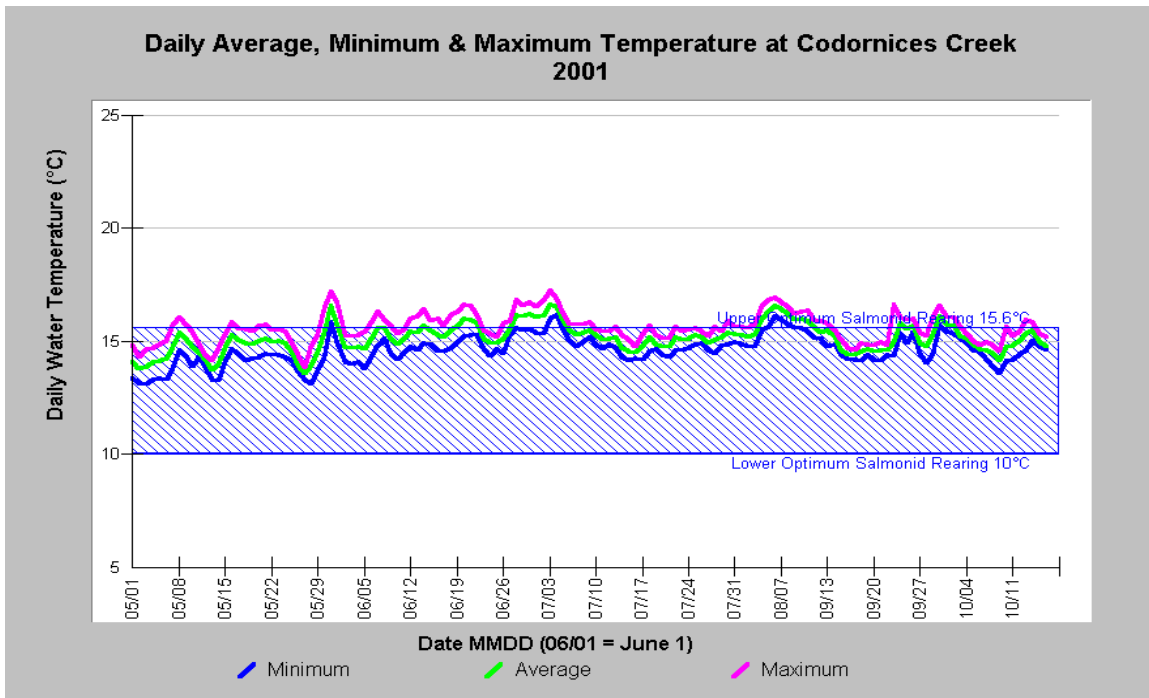
Figure 13. Friends of Five Creek's May-October, 2001 water temperature record

As reported in Appendix A, the Friends of Five Creeks (FFC) collected samples for turbidity, dissolved oxygen, and biochemical oxygen demand (BOD) analysis during the 1999 and 2000 water years. In 2001 they maintained a temperature recorder throughout the summer near the BART crossing. Figure 13 interprets FFC's 2001 temperature data in the Klamath Resource Information System, or KRIS, format. The KRIS program (see www.krisweb.com) has been used, through the courtesy of the non-profit Institute for Fisheries Resources (www.ifrfish.org), to capture, maintain, and interpret the data collected in this CCWRAP project.

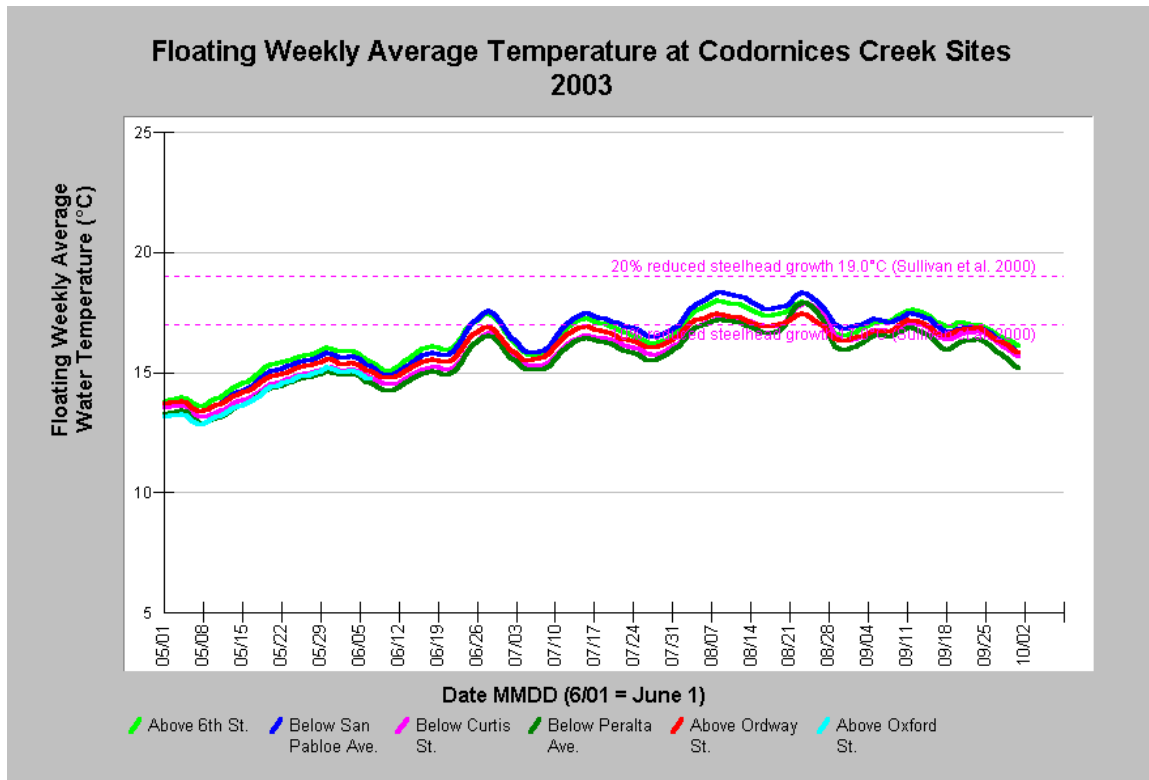
Figure 14. Floating weekly average water temperatures at six sites in Codornices Creek during 2003

Figure 14, on the next page, shows the floating weekly average water temperatures, or MWAT, of five pools in Codornices Creek during the May-October, 2003 period -- plus those for the May-June record at the Oxford Street site. Water quality regulators and aquatic researchers believe that MWAT better describes the *duration* of high temperatures and their effects on aquatic organisms, including salmonids.

A review of steelhead growth studies by Sullivan et al. determined that compared to the optimum temperatures range of 10-15.6°C, an MWAT of 17°C can diminish steelhead growth by 10 percent and an MWAT of 19°C can reduce growth by 20 percent (Sullivan, 2000).

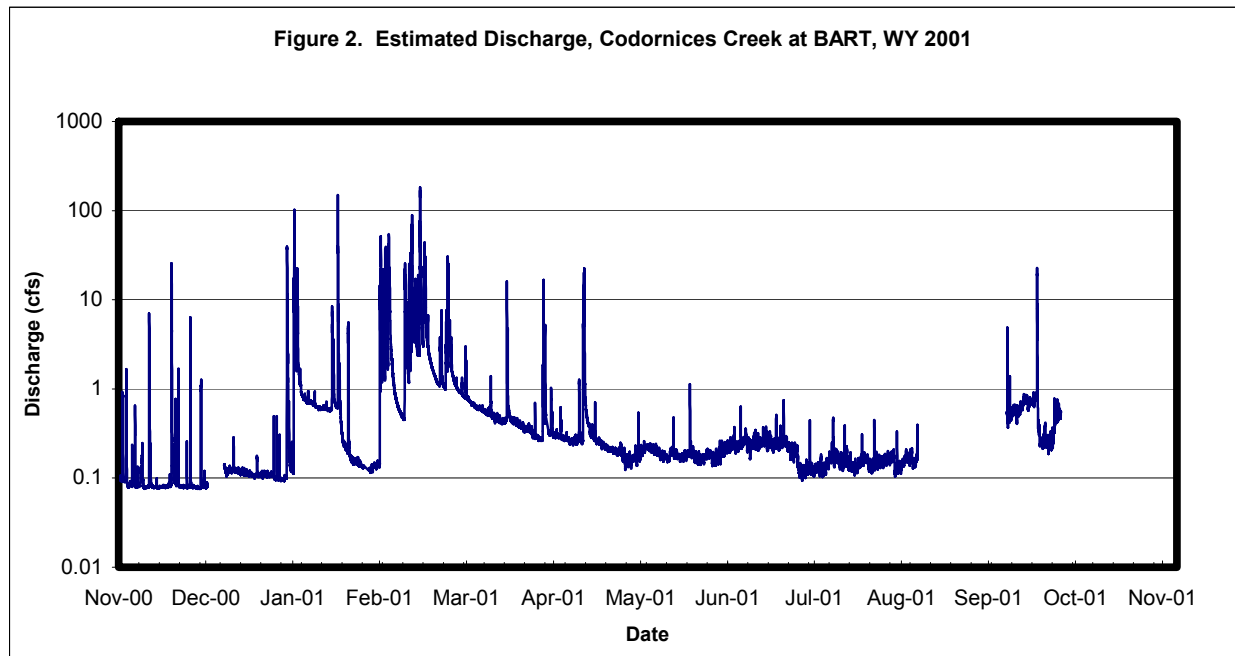
Figure 2 shows the runoff hydrograph for most of the 2001 water year. Note that most of the time the discharge is less than 1.0 cfs, but that it sometimes exceeds 100 cfs.¹ The hydrograph also shows some curious spikes in discharge during the summer months. This is probably caused by so-called “nuisance flow” associated with landscape irrigation, washing of cars, or leaks in water supply pipes.

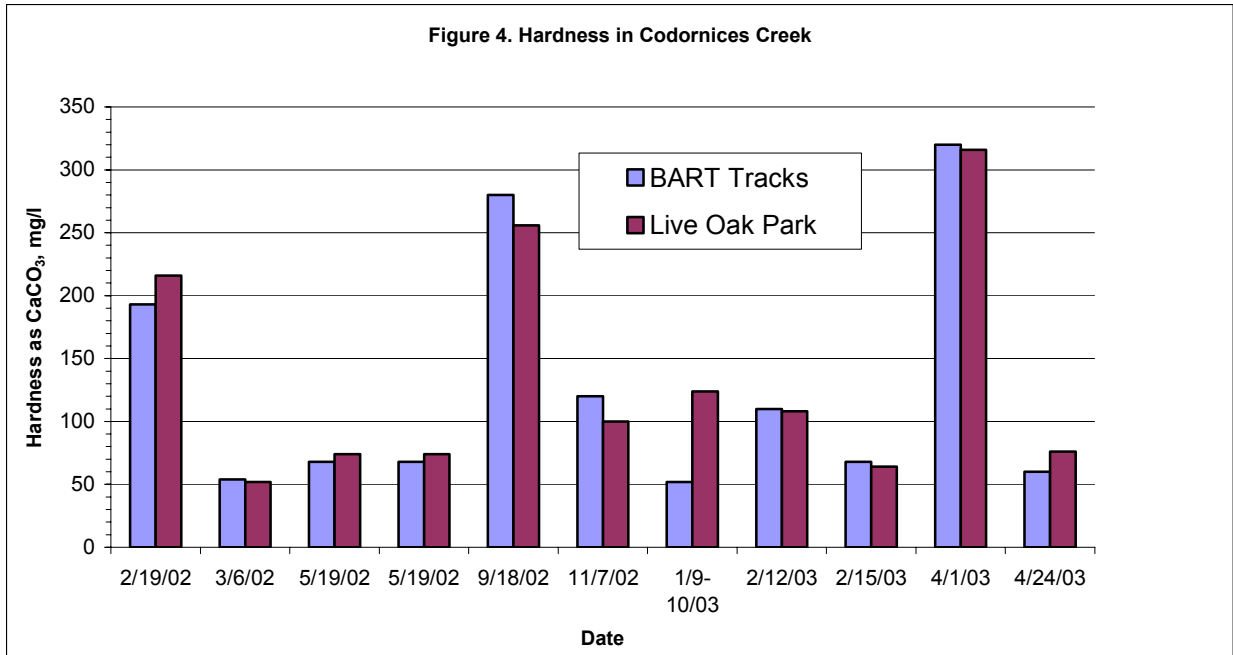
Figure 4 shows the hardness in samples collected at the same time that samples were collected for heavy metals. Hardness varied from just over 50 mg/l to over 300 mg/l. As expected there is not much difference between the hardness at the two sampling sites on a given day (in January 2003, a sample was collected at BART crossing on the 9th and at LOP on the 10th). In general, hardness is inversely related to discharge, reflecting the relative contributions to the stream of surface runoff and groundwater.

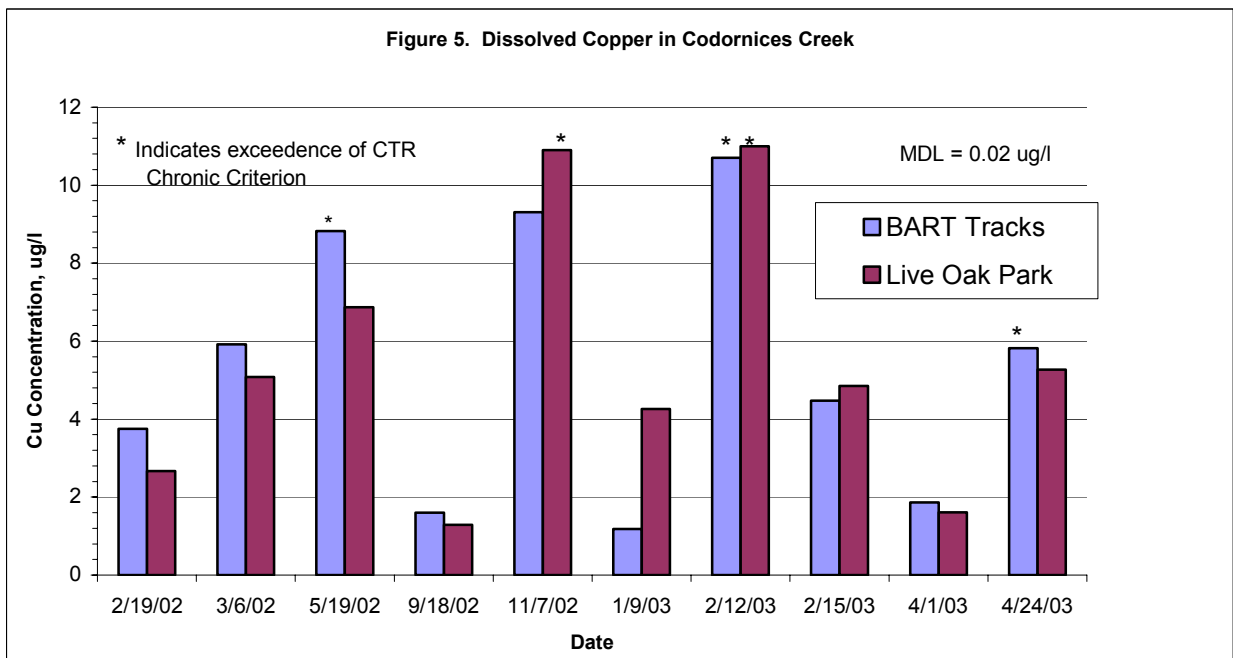
The concentrations of dissolved lead and zinc never came close to the CTR chronic criteria for aquatic life. Dissolved copper, however, did exceed the chronic criteria in 3 samples at the BART crossing, and 2 samples at LOP. Figure 5 shows the results for copper. The acute criteria for aquatic life were not exceeded in any of the samples.
