Codornices Creek Restoration Project

2016 Monitoring Report

City of Albany / City of Berkeley

Prepared By:
Restoration Design Group
2612 Suite B, Eighth Street
Berkeley, California 94710

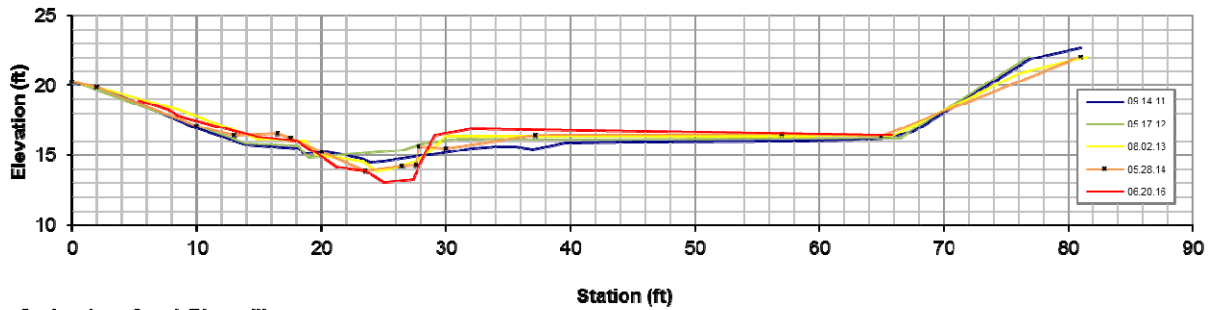
Codornices Creek Phase III
Cross Section 1
Profile Station 0+81

The two riffle cross sections were resurveyed in 2016. Cross section #1 is in the lower portion of the creek and is influenced by the culvert backwater. Cross section #2 is upstream in the location adjacent to the hardpan bed. Cross section 1 shows continued adjustment of the channel above

the 6th street culvert, with active narrowing of the channel. Cross section 2 continues to build its inner depositional bench formed in 2012, while maintaining a consistent thalweg elevation.

Above 6th Street Culvert – The hydraulics of the culvert backwater resulted in deposition of sediment in the channel upstream of the culvert and a near immediate evulsion and straightening of the channel leading into the culvert. For the next five years, the changes to the channel in this area have slowed as the channel approaches an equilibrium condition. The

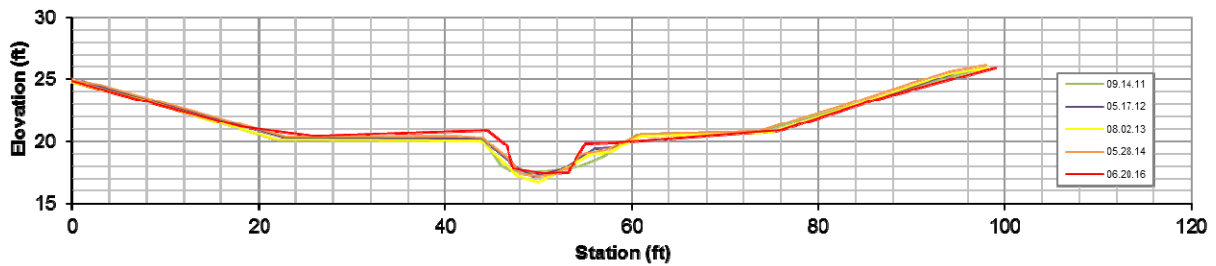
Codornices Creek Phase III
Cross Section 2
Profile Station 4+34

Expose Hardpan –The exposed hardpan upstream continues to persist. This hardpan substrate excludes any opportunity for hyporheic flow and does not provide ideal habitat for benthos. This condition is not unique to the restoration areas. A similar condition exists upstream of the project site between 8th and 9th street.

Monitoring of this condition began during the first winter after construction and has not shown any indication of improvement. The channel has incised up to 1-foot below the design grade resulting in increased stream power near bankfull flows. In addition, the floodplain is no longer inundated at the designed frequency.

As noted above, there is a large portion of channel that has hard pan clay substrate and does not provide suitable habitat and likely contributes to the elevated stream temperatures seen within Phase 3. Addressing this condition should be considered if there is interest from the regulatory agencies.
